## Diagnosing Bent Steering and Suspension Components Using Steering Geometry Angles

# DIAGNOSING AND REPAIRING BENT SUSPENSION COMPONENTS

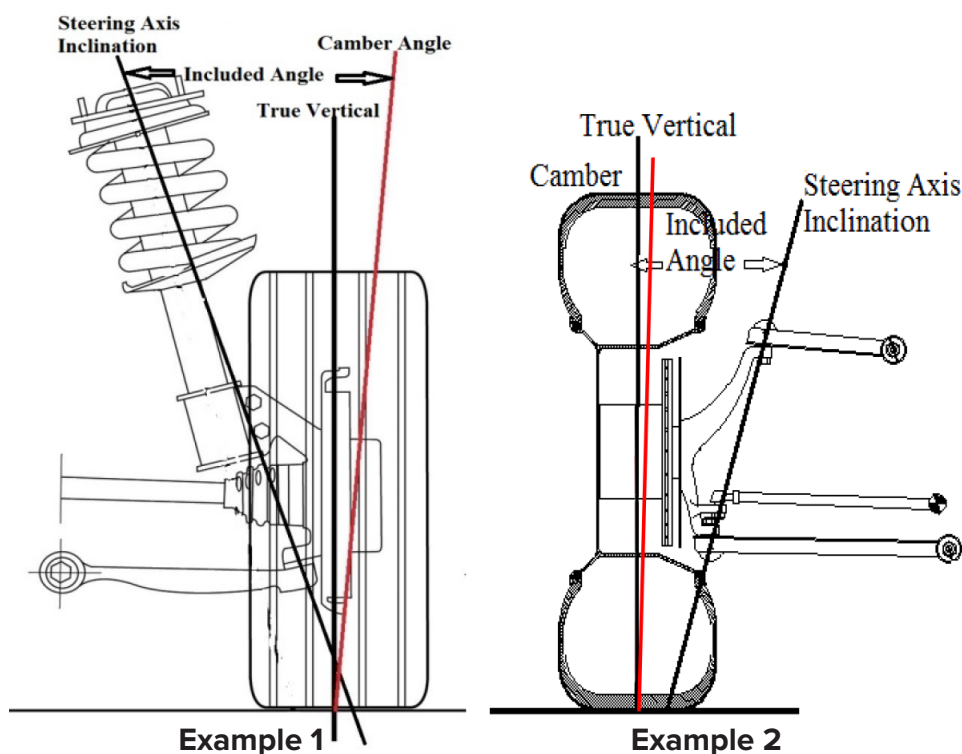
The alignment angles we use to do this are Camber, S.A.I. (Steering Axis Inclination) and I.A. (Included Angle). S.A.I., also known as King Pin Inclination (K.P.I.), is the angle between the true vertical and a line drawn through the centre of the strut's top pivot (or upper ball joint) and the lower ball joint. It is sometimes difficult to obtain an OE specification on S.A.I. and so we recommend keeping a record of SAI angles to obtain an average figure which becomes your specification for a particular vehicle.

$S.A.I. + \text{Camber} = I.A.$

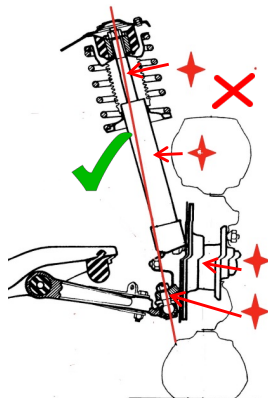
Example 1

The Included Angle on the LH side is within OE specs, but the RH side is 2° out. Because the RH side S.A.I. is to specification but its Included Angle is incorrect, we know that the fault exists outboard from the steering axis pivots.

The components that are outboard from the steering axis pivots are the ball joint stud, the strut shaft, the strut body and the forged stub axle or the knuckle assembly.

A car with MacPherson Strut suspension has the following camber readings:

RH = -1° LH = +1° 10' OE spec = +1°

RH = 7° 15' LH = 7° 00' OE spec = 7°

RH 6° LH 8° 10'

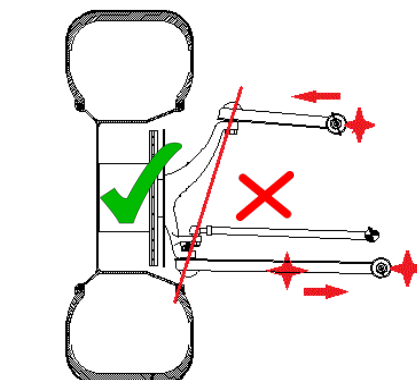
Example 2

This vehicle obviously has a camber problem, but the Included Angle is to specification. Because of this we know that all the components between the two steering pivots and the wheel are in correct alignment.

This means the problem is inboard of the steering axis pivots. The possible faults are a bent chassis, incorrectly positioned ball joints, stretched top arm, bent lower arm, worn upper or lower pivot bushes.

A vehicle with twin lateral arm suspension has the following wheel alignment specifications:

RH	LH	OE
Camber 2°	20'	-0° 20'	-0° 15'
S.A.I.	5° 55'	8°30'	8°35'
I.A.	8° 15'	8° 10'	8°20'

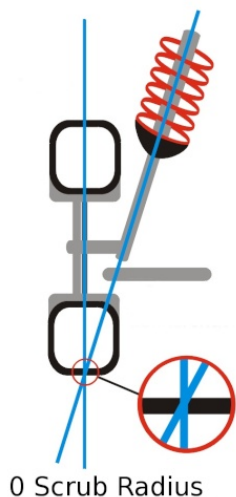
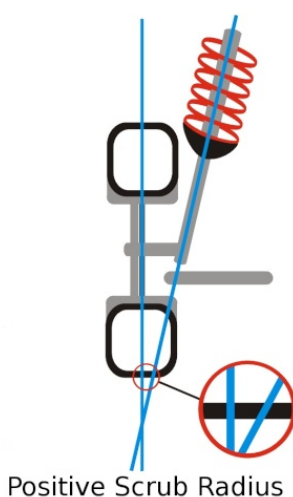
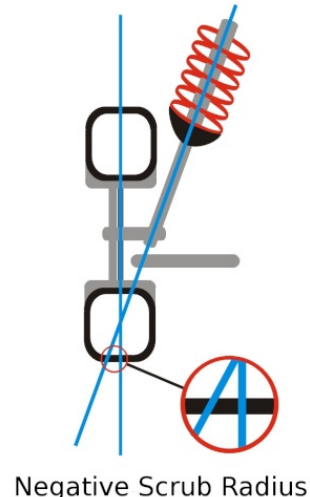
Scrub radius or scrub distance is the distance between the centre of the tyre's footprint and the point at which the steering axis meets the road surface. Zero or neutral scrub radius is when the steering axis meets the road surface at the centre of the tyre's footprint. Scrub radius is positive when the steering axis meets the road inboard of the centre of the footprint; and it is negative when the steering axis meets the road outboard of the tyre's centre.

Positive scrub radius causes the wheel to pull outwards and the opposite is true for negative scrub radius. When a front brake fails on a RWD vehicle, severe brake pull can occur. When a front brake fails on a FWD vehicle, the chassis would still try to pivot around the wheel which is braking, but because it has a negative scrub radius the wheel will try to turn in, thus counteracting the pivoting of the chassis. The result - the vehicle stops in a straight line.

Most rear wheel drive vehicles have positive scrub radius of between 25 - 50mm and all modern front wheel drives have negative scrub radius of 2 - 6mm. The change from positive to negative scrub radius resulted from the introduction of diagonal split braking systems.
